# YZ125G

## CARBURETOR MODIFICATION

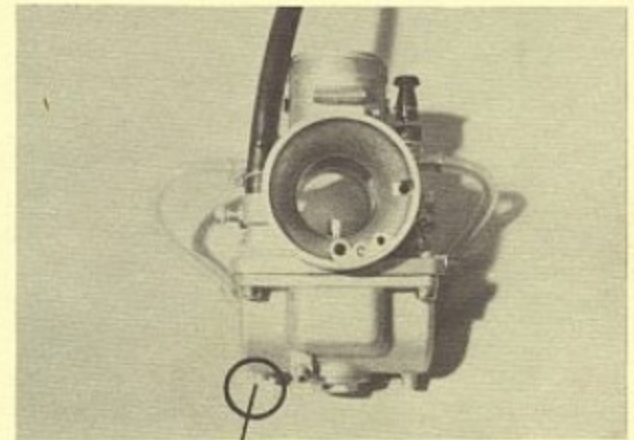
The float bowl dowel pin support on the bottom of the left-hand side of the carburetor (as you sit on the motorcycle) hits the transmission under extreme riding conditions. The carburetor vibrates and causes the gasoline to foam. In order to prevent the gasoline from foaming, a slight modification is necessary to the carburetor. Follow the procedures given below.

GRIND 3mm OFF

2. Disconnect and remove the carburetor.
3. File or grind 3mm off the left-hand float bowl dowel pin support.

4. Seal the hole in the dowel pin support with epoxy glue.
5. Reinstall and reconnect the carburetor.
