DATE August 19, 1982

YZ125J ROTOR PULLER MODIFICATION

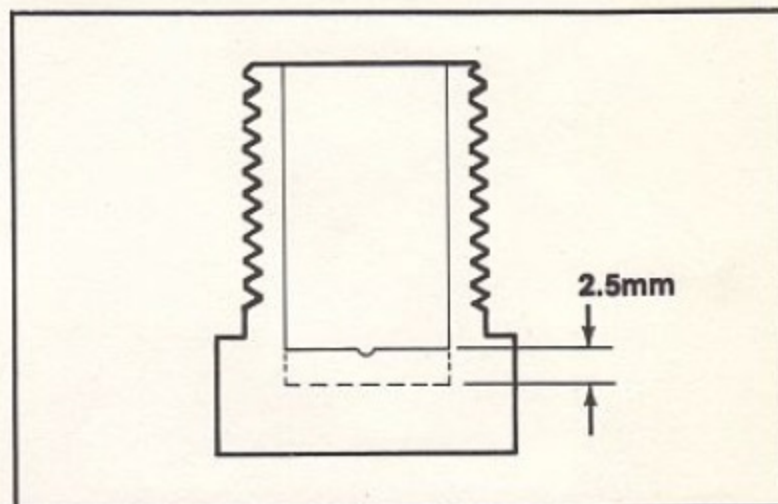
The rotor pullers for the YZ125J, including those in the owner's tool kit, do not fit properly. Because the end of the crankshaft is lengthened, the puller does not adequately engage the threads in the rotor; when the puller is tightened, threads in the rotor may be pulled out of the rotor.

Note that the bottom of the hole has been machined flat; this must be done to avoid damage to the crankshaft.

To correct this problem, Kent-Moore has modified their stock of pullers. The pullers have been remachined as shown in the illustration.
