DATE March 29, 1983

YZ250K/490K RIGHT-HAND SIDE COVER BREAKAGE

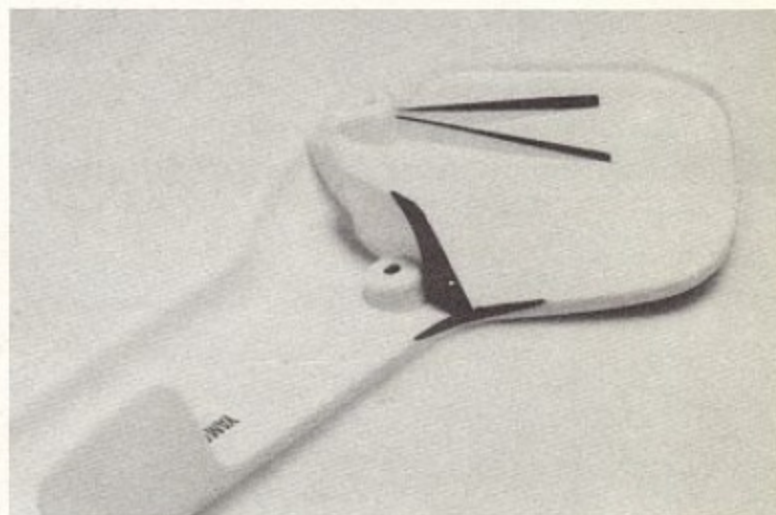
The right-hand side cover on YZ250K and YZ490K models may break under certain conditions. To make this breakage less likely, modify the inside of the side cover as shown.

Remove the material indicated by the black areas in the photo. A bench grinder may be used to remove the material. Take care to make all edges smooth.
