## AFFECTED MODELS

All YZ125H

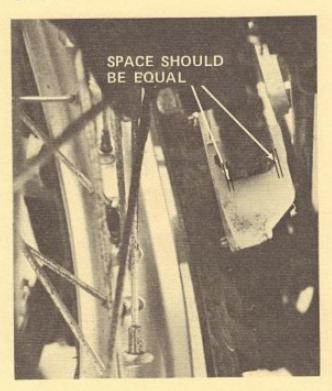
Rap the chain guide with a plastic mallet, and bend the chain guide bracket towards the frame. Apply the minimal force needed to bend the chain guide in line with the chain. Be sure the chain runs through the middle of the chain guide as shown in the photograph.

The chain guide on some of the affected models is not properly aligned with the chain. As a result of this misalignment, the chain hits the guide and falls off the driven sprocket during operation. To avoid this problem, inspect the chain guide on each affected model during predelivery. If the guide is not properly aligned with the chain, carefully bend the chain guide bracket until the chain runs through the middle of the guide.

Instruct your customers to inspect the chain guide after each race. Rocks or other debris can bend the chain guide.
